Subject: City of Thornton – Loma Linda Park ADA Assessment

Figure 1: Loma Linda Park ADA Assessment Area

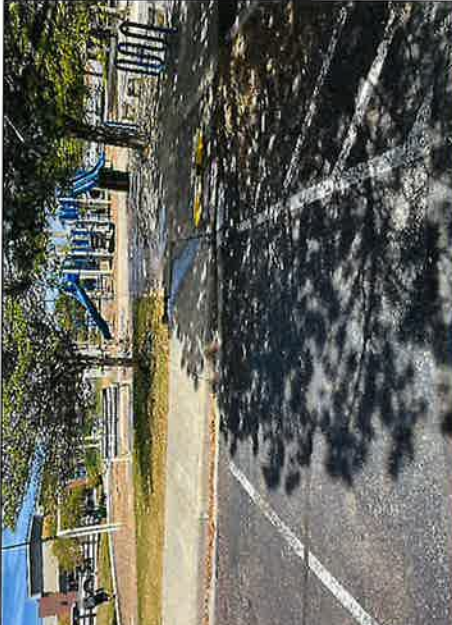
<p>PA 1</p>	<p>Parking stall and striped aisles cross slope exceeds max (3% and greater), no ADA stall striping or signage.</p>	<p>When parking lot is repaved, achieve max cross slopes for ADA parking stall, striped aisle, and path to nearest curb ramp. Install ADA striping in stall and ADA signage.</p>

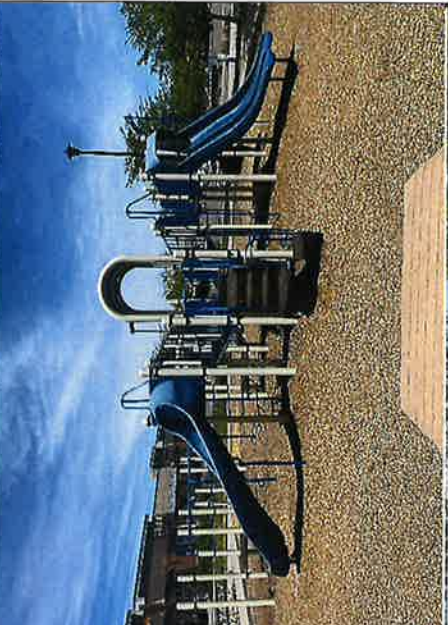
<p>PG 1</p>	<p>No accessible route provided to or within playground area, insufficient number of accessible ground level play components, non-compliant playground surface.</p>	<p>Provide one accessible route to playground. Provide accessible route within playground area. Install playground surface that meets criteria for friction/turning.</p>
