ADDENDUM NO. TWO

REQUEST FOR PROPOSALS

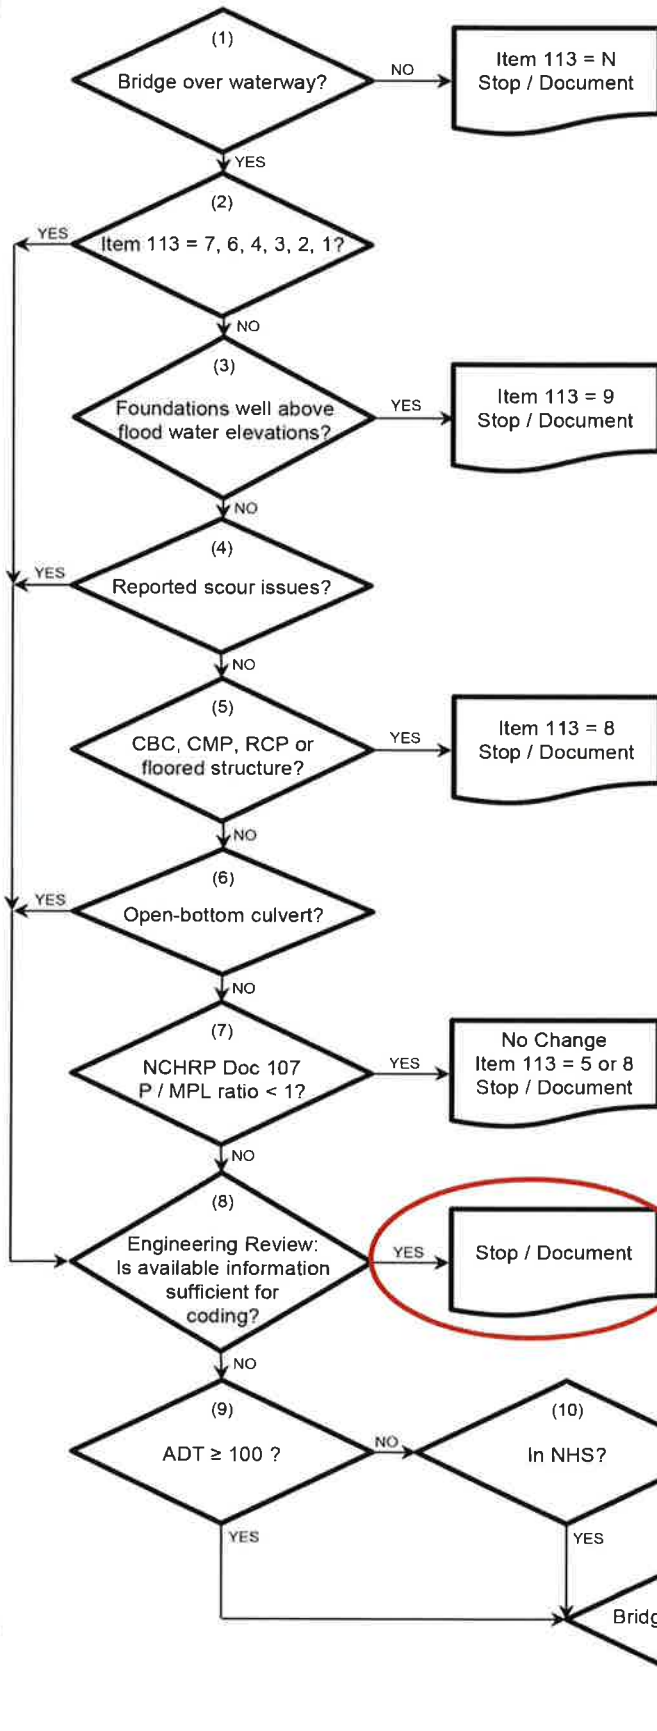
STRUCTURE ID: THN-136WAS-BDC
 FACILITY CARRIED: 136th Avenue
 FEATURE INTERSECTED: Big Dry Creek

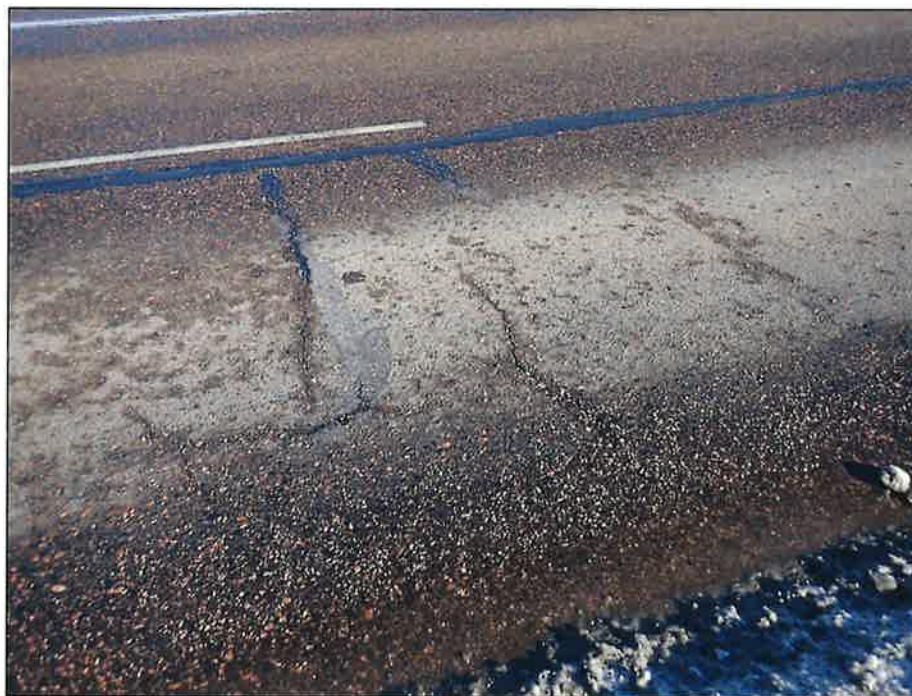
Typical Unsealed Cracks and Tar-Sealed Longitudinal Cracks in the Deck Asphalt Wearing Surface, Looking North

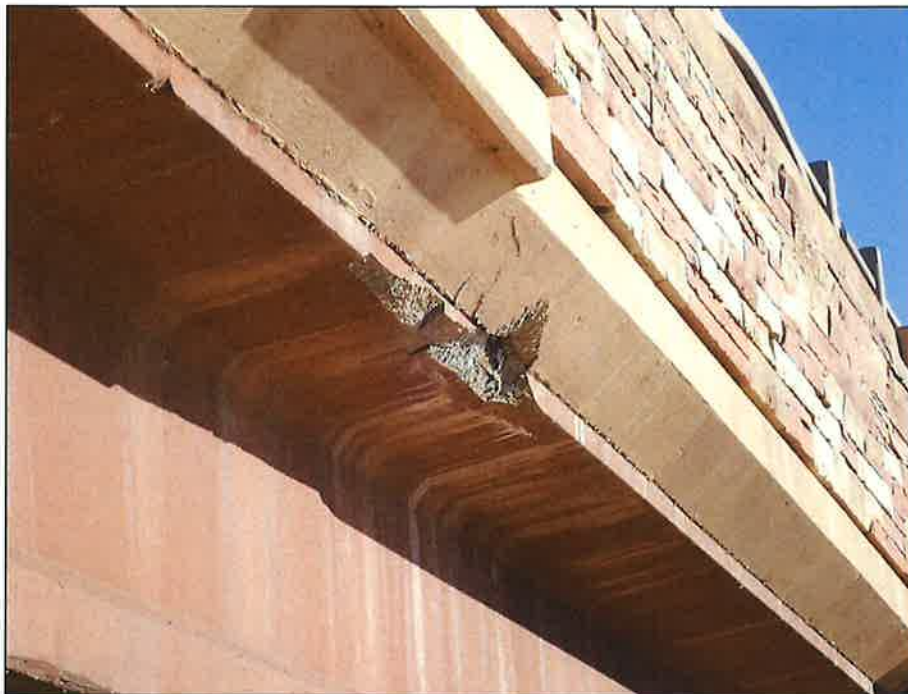
Spall with Exposed Rebar in the Exterior Top Flange of Girder 1O, 20 Feet West of Pier 2, Looking East

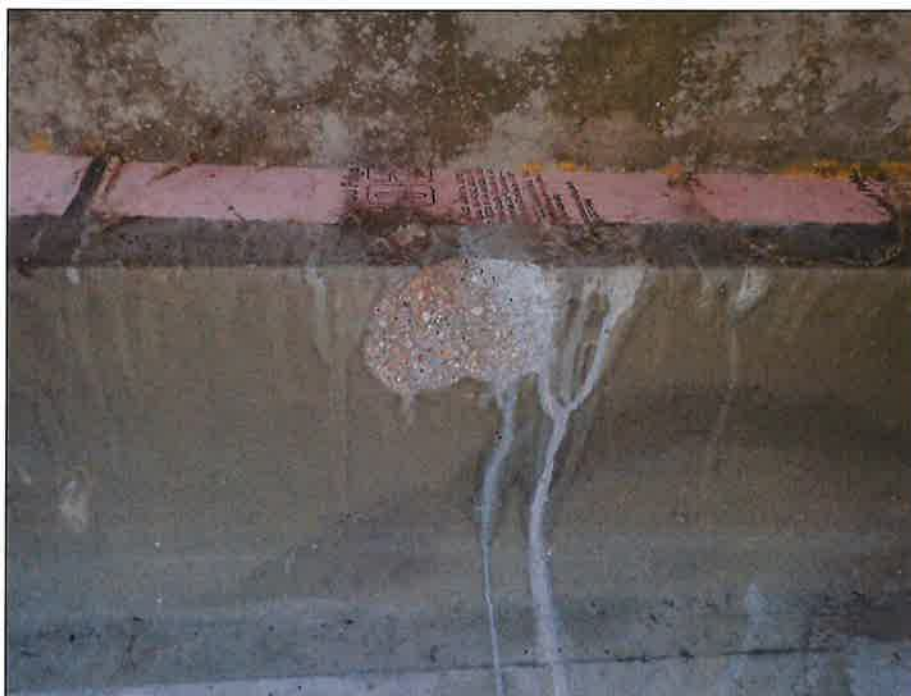
Spall in the Top Flange of Girder 1E at the West Abutment, Looking South

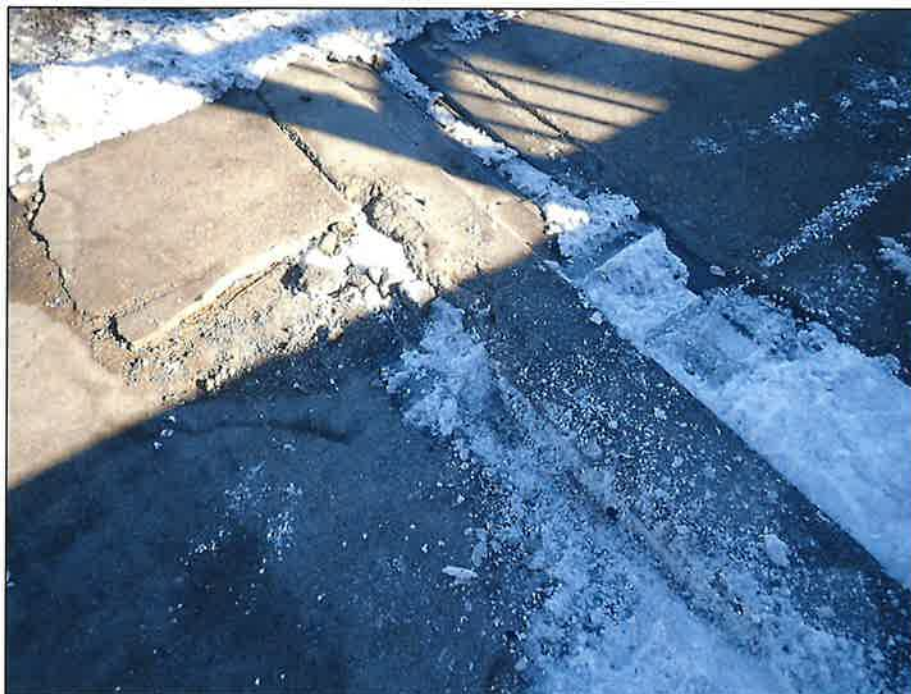
Missing Sidewalk Cover Plate and a 1.5 Inch Lip at the Southwest Corner, Looking East

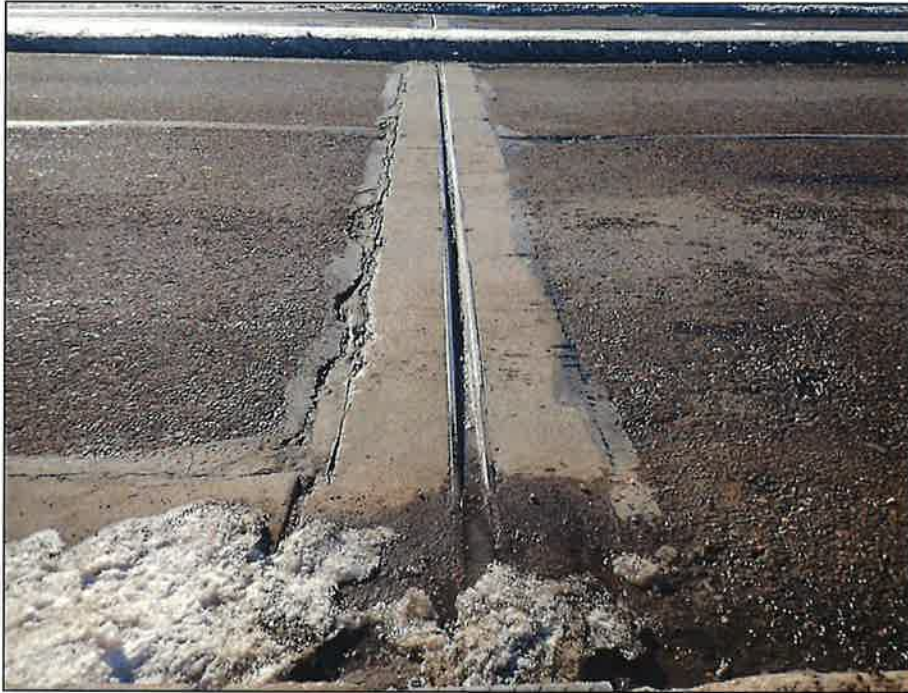
Typical Partial Loose Debris Impactation of the Strip Seal Expansion Joints,
Looking South

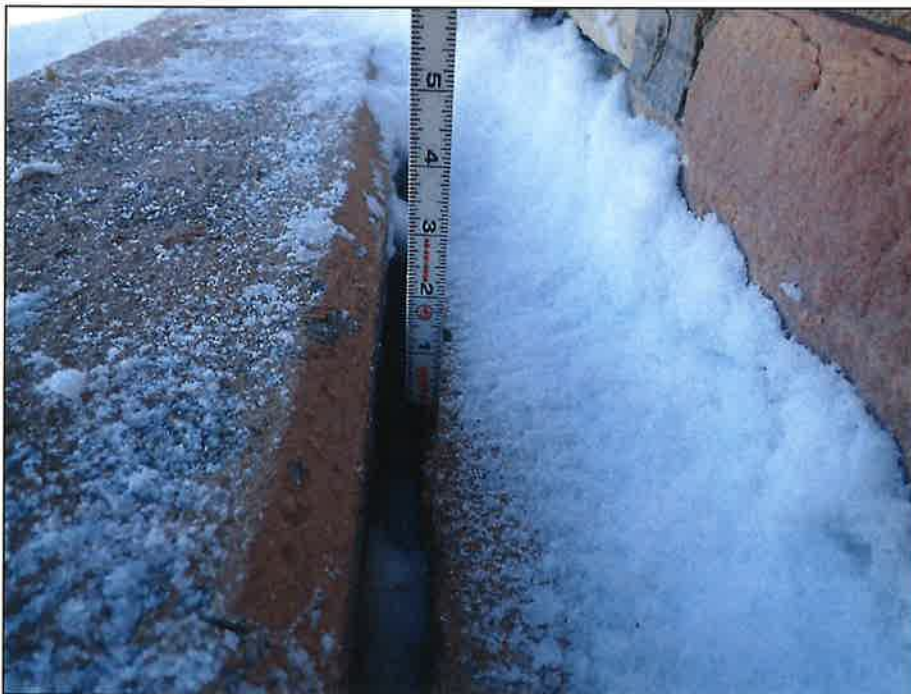
Typical Settled Approach Slab, Evident from the Differential Along the
Edge of the Wingwalls at the Corners, Looking East
