Comments **POSTING NOT REQUIRED**

3" asphalt on 8" concrete deck composite on BT42 prestressed concrete girders @ 6'-6" o.c., 2 spans

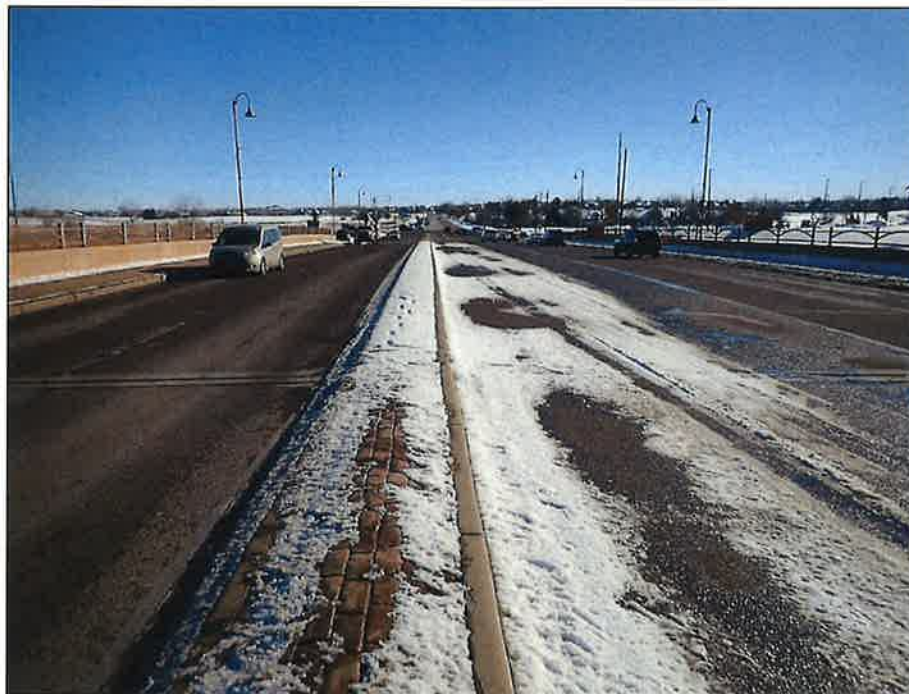
Roadway, Looking East

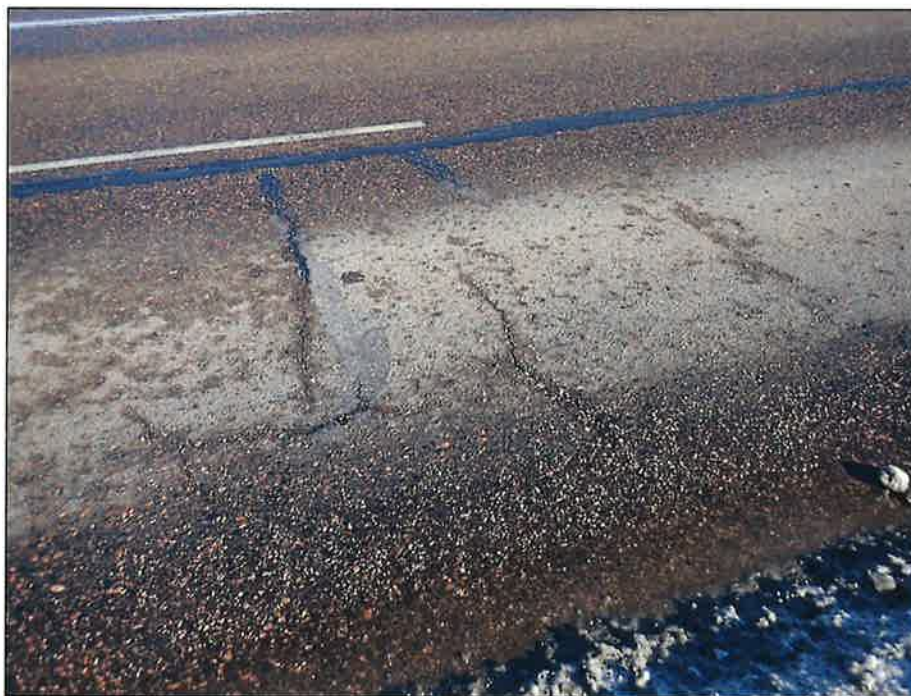
Typical Unsealed Cracks and Tar-Sealed Longitudinal Cracks in the Deck Asphalt Wearing Surface, Looking North

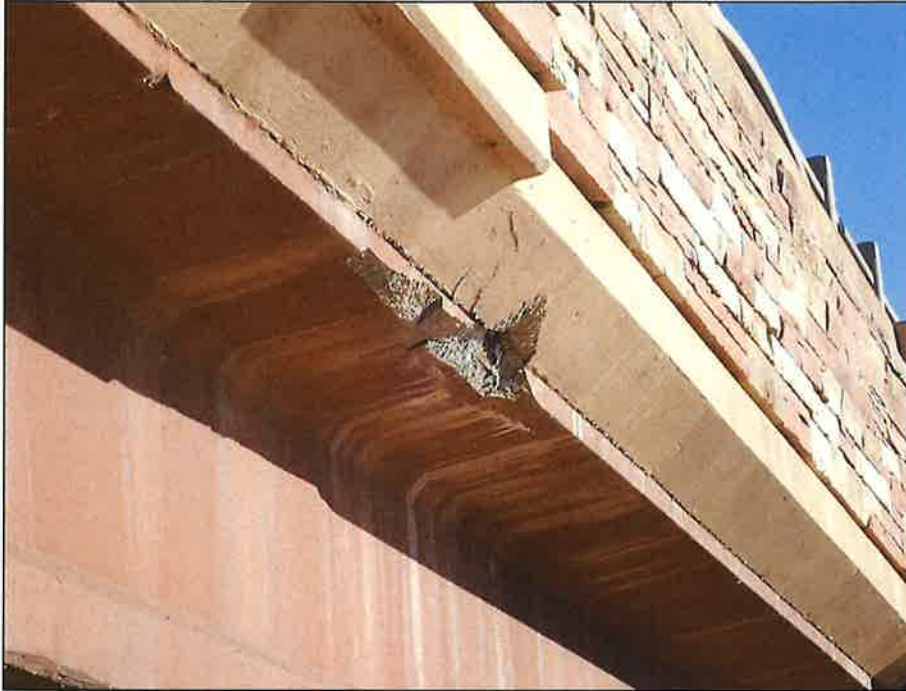
Spall with Exposed Rebar in the Exterior Top Flange of Girder 1O, 20 Feet West of Pier 2, Looking East

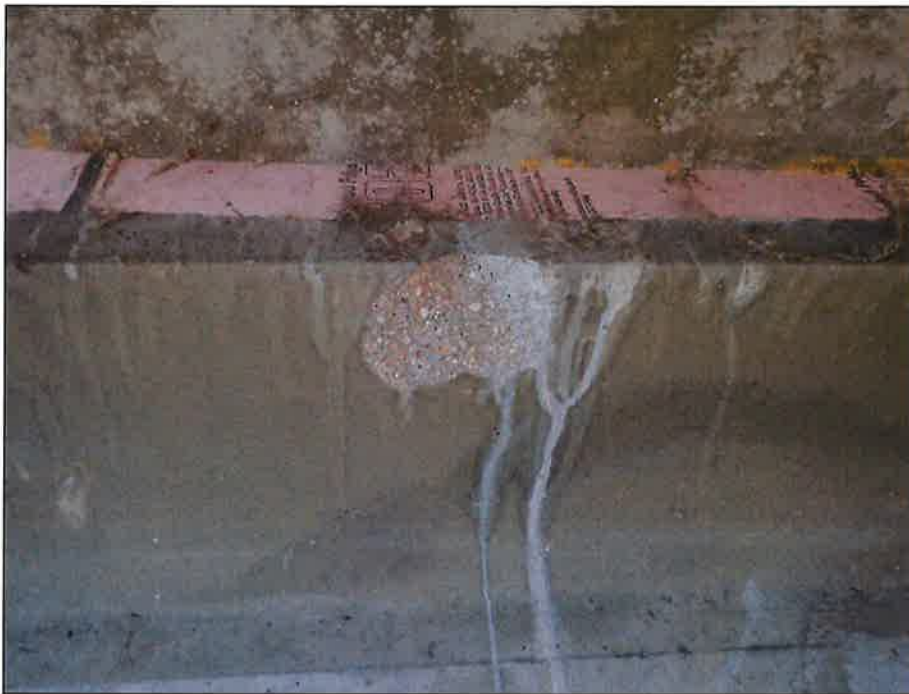
Spall in the Top Flange of Girder 1E at the West Abutment, Looking South

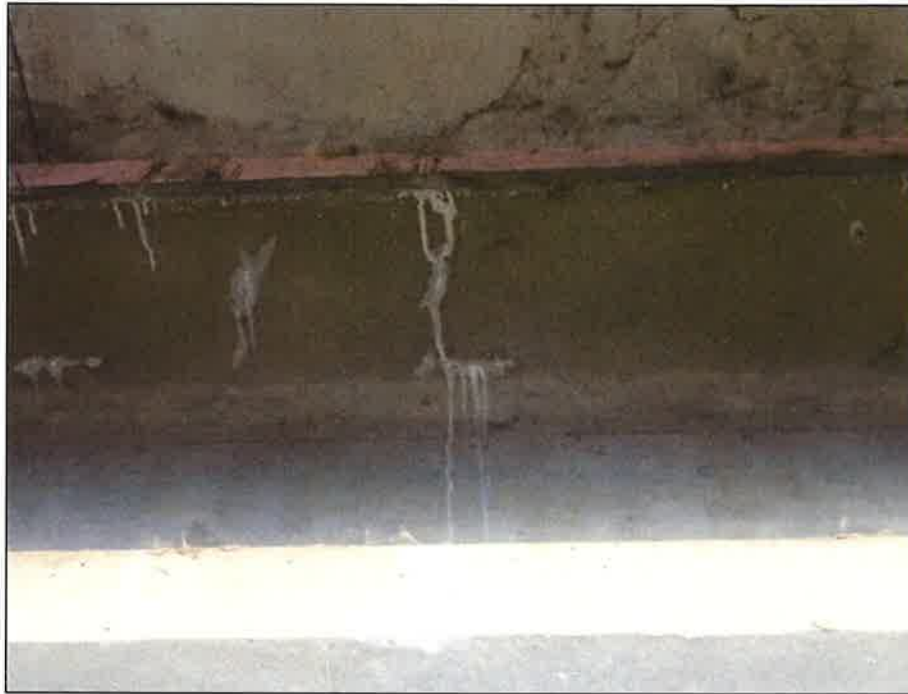
Typical Short Transverse Cracks with Efflorescence in the Underside of the Top Flanges of Several Girders, Looking South

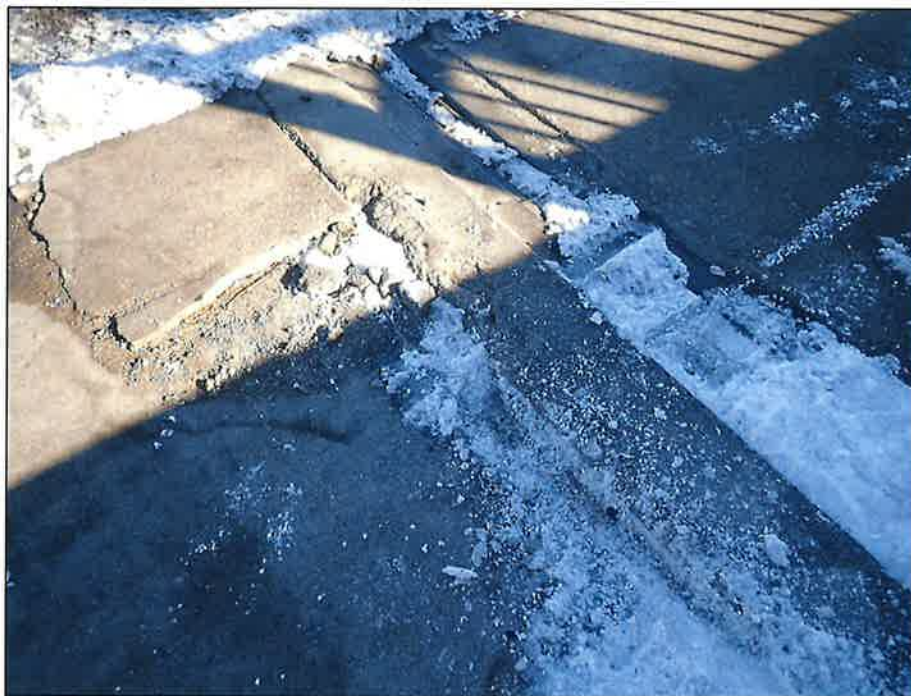
Missing Sidewalk Cover Plate and a 1.5 Inch Lip at the Southwest Corner, Looking East

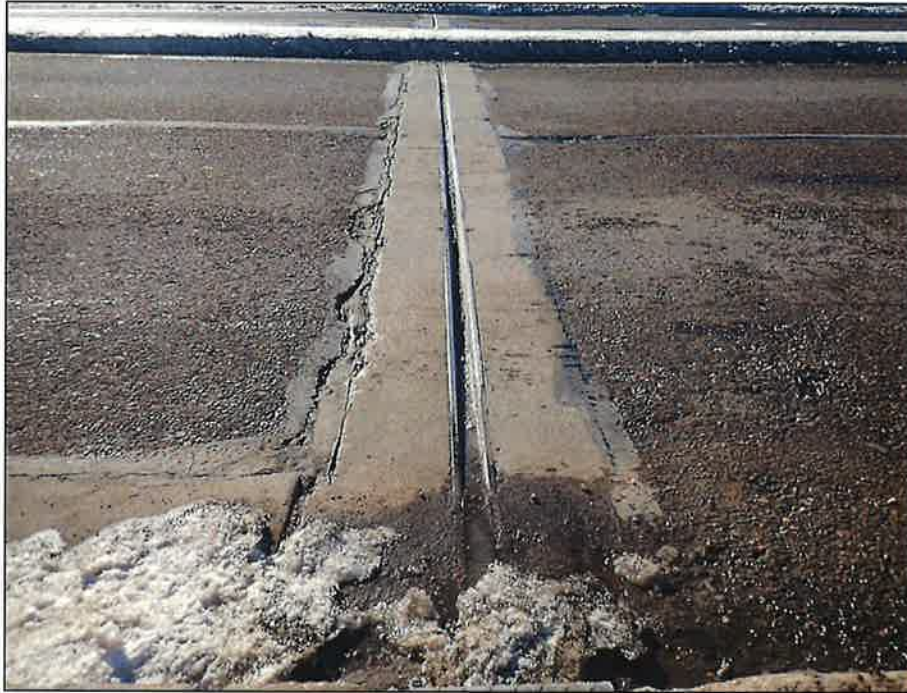
Typical Partial Loose Debris Impactation of the Strip Seal Expansion Joints,
Looking South

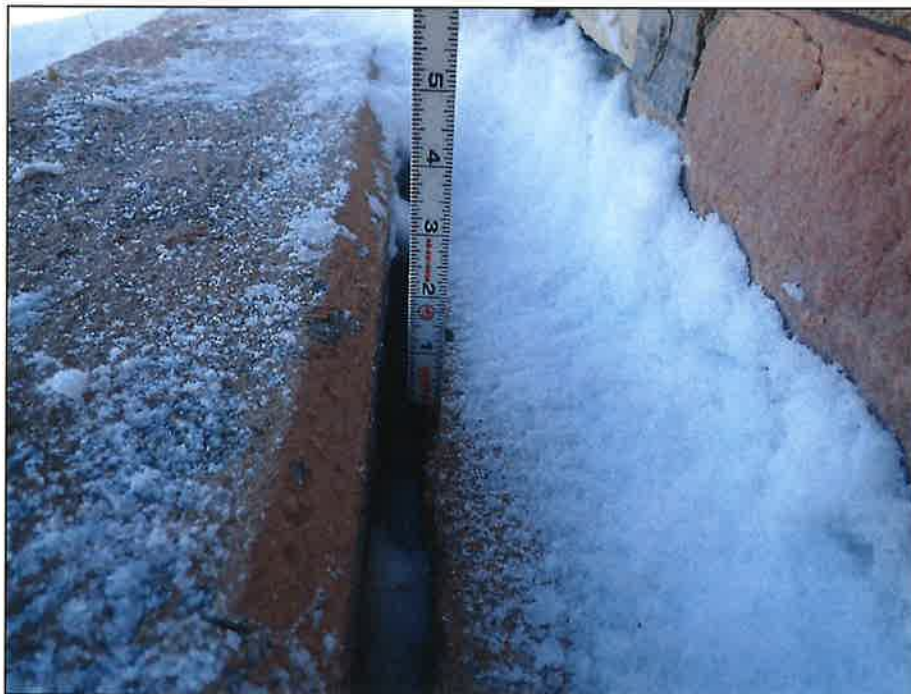
Typical Settled Approach Slab, Evident from the Differential Along the
Edge of the Wingwalls at the Corners, Looking East

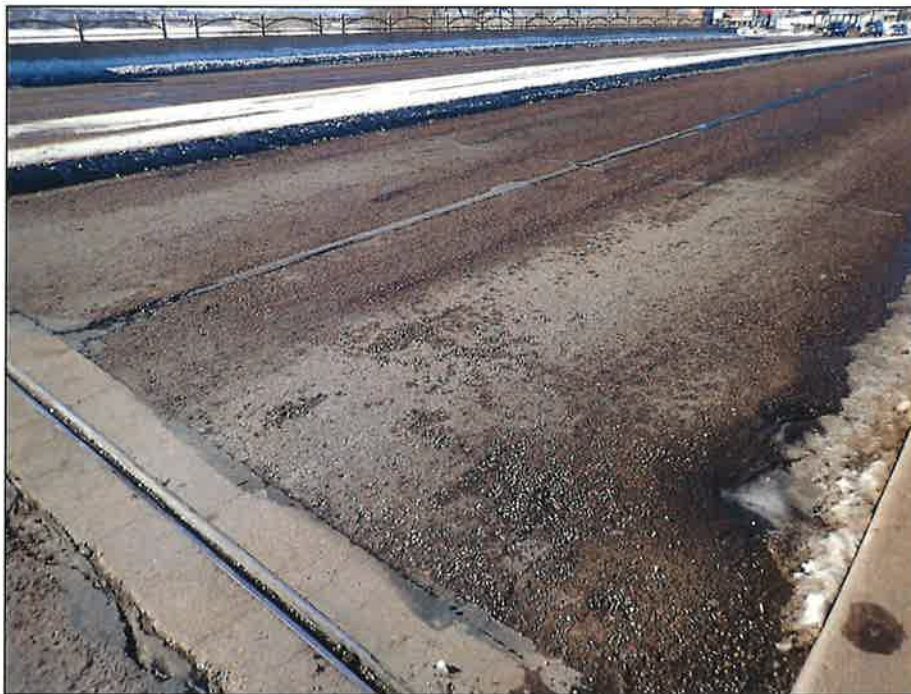
Typical Potholes Adjacent to the Sealed Gap in the Approach Slab Wearing Surfaces, Looking Northwest
