**AYLOR PROPERTY
13981 QUEBEC STREET, THORNTON, COLORADO
ABATEMENT, DEMOLITION, AND REMOVAL
PROJECT CIP 22-109A**

REQUEST FOR PROPOSALS

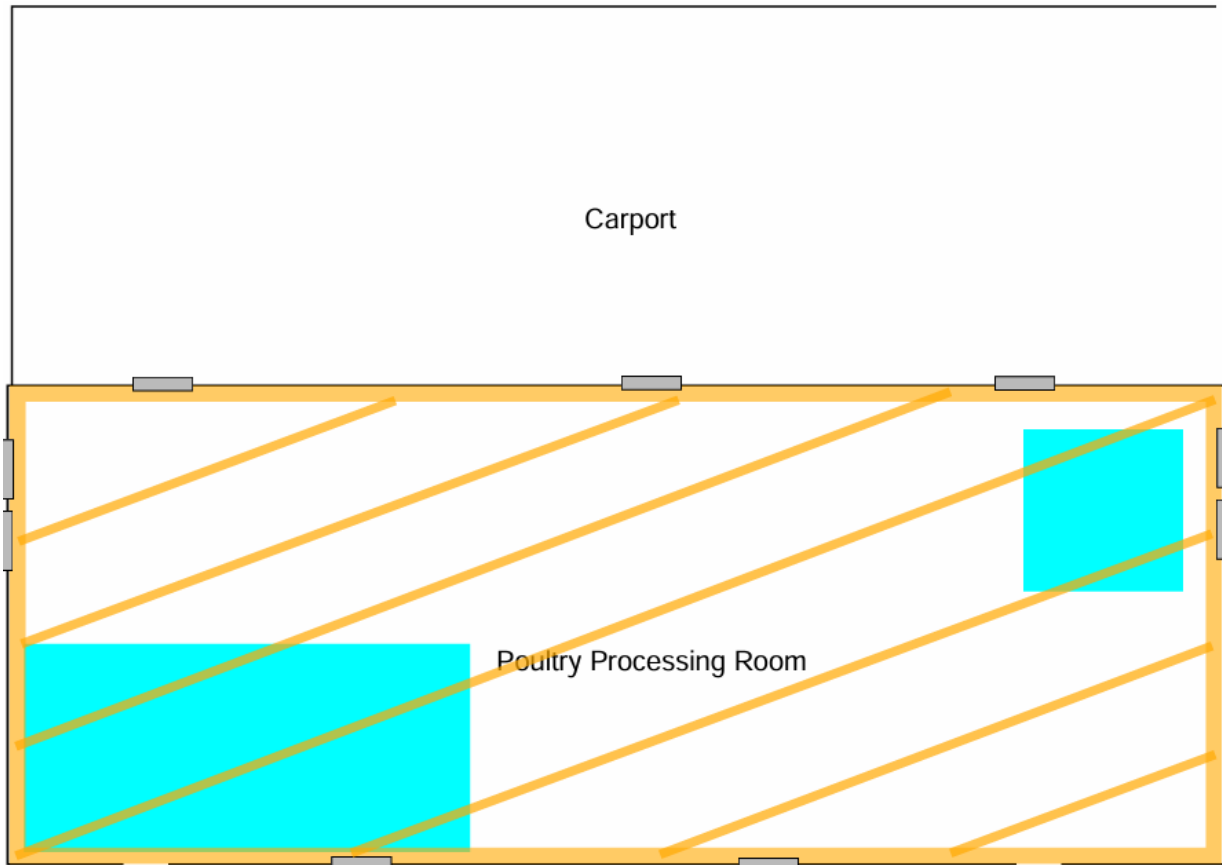
APPENDIX B: SPILL AREAS FLOOR PLANS

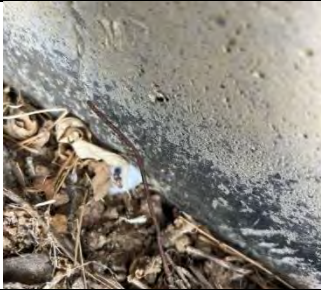
~6 SF	NO – Non-Friable
Joint Compound Associated with SM3 (JC3)	Original Structure – Den Area South & West Walls under Wood Paneling and North & East Walls under Wood Paneling and Drywall

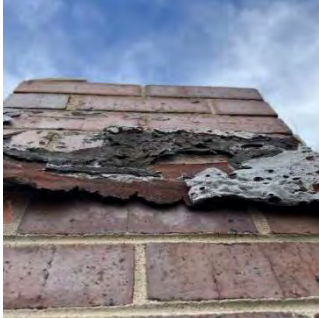
~6 SF	YES – Friable
Black Tar Sealant (5-CMUP1)	CMU walls, crack patches Sealant around windows

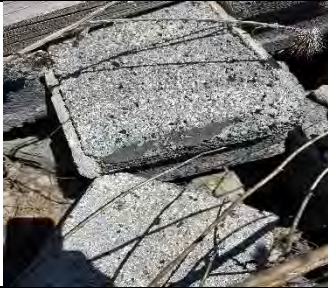
<p>~90 SF</p>	<p>YES – Friable</p>
<p>Black/Grey Tar Sealant (5-CMUP2)</p>	<p>CMU walls, crack patches Sealant at wood/CMU roof rim</p>	 	<p>~260 SF</p>	<p>YES – Friable</p>

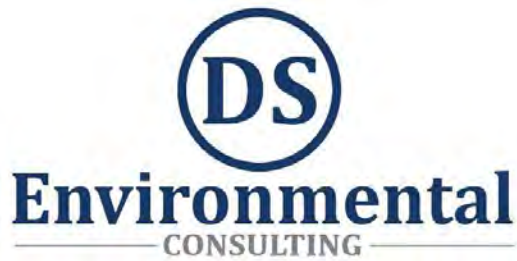
“The trusted choice for your environmental & industrial hygiene needs.”

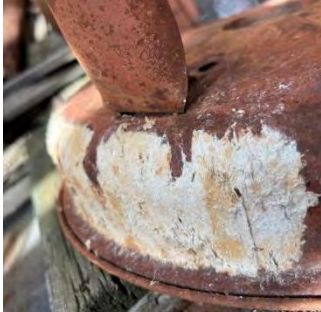
ACMs REQUIRING ABATEMENT				
ACM Description (HA ID)	ACM Locations <i>See Appendix C for Material Map</i>	Material Photograph	Quantity	Require Abatement?
Off-White Fibrous Paper (9-DW1)	Bottom of propane burner stands and debris on interior

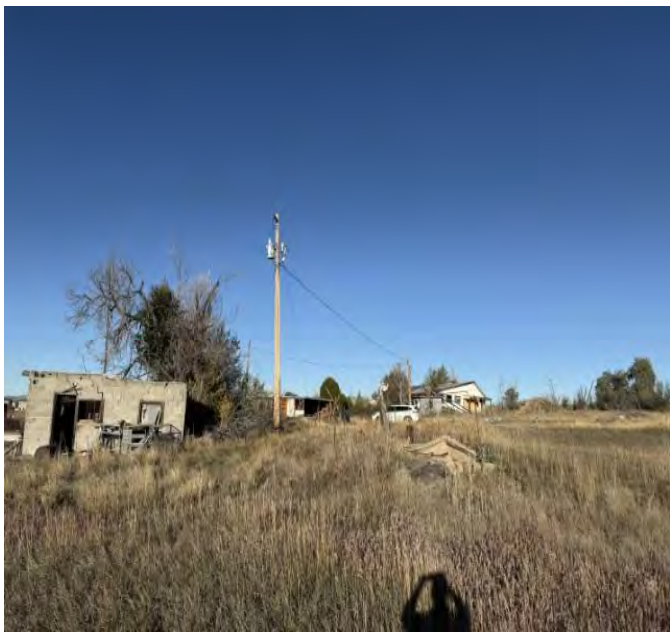
Description: Overview of the Buildings onsite looking NW

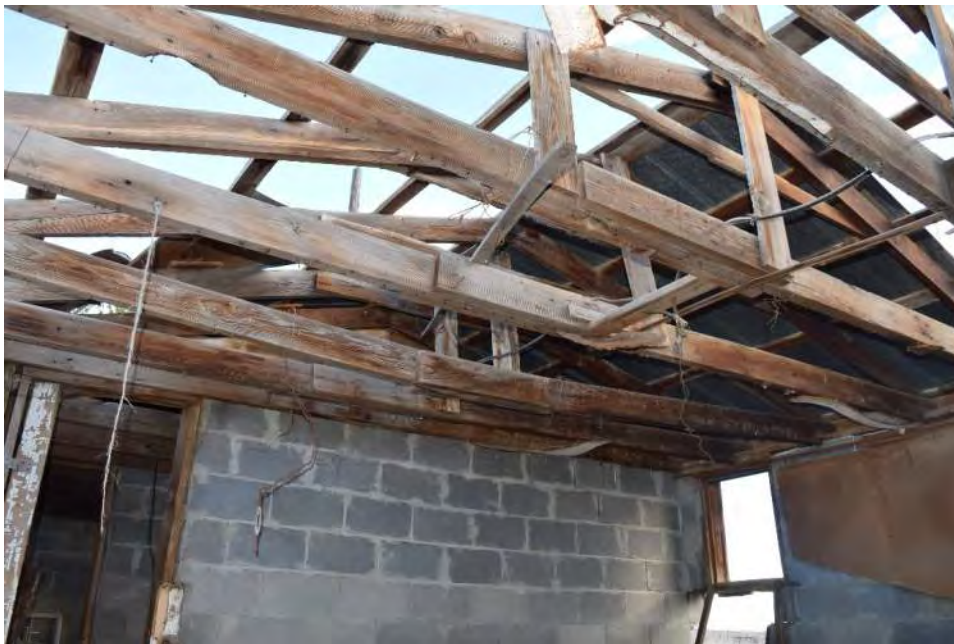
Figure 9. Wood roof trusses of Outbuilding #2 deflecting and showing signs of deterioration.

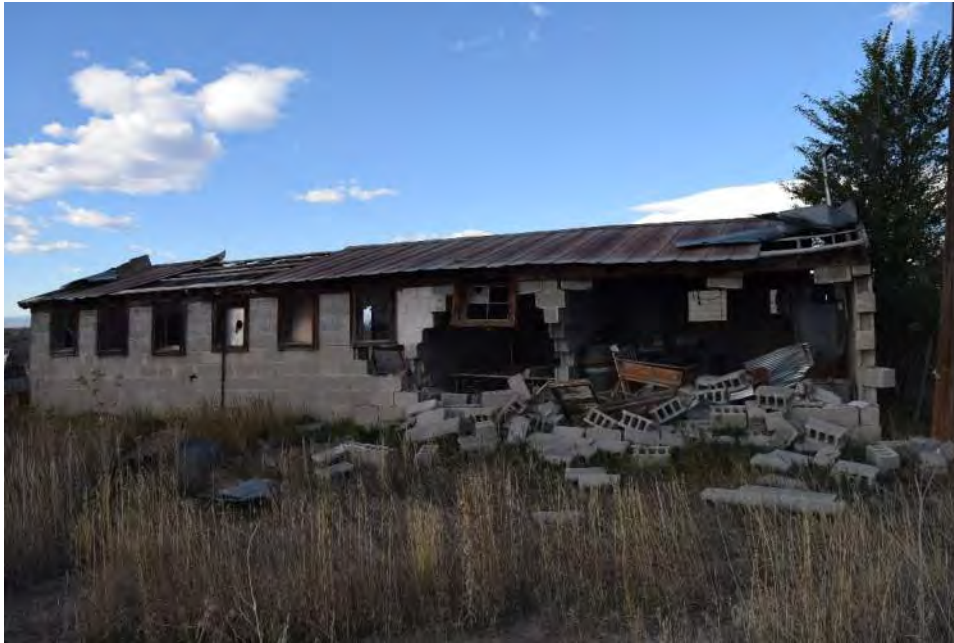
Figure 10. Collapsed north half of the east wall of Outbuilding #2.

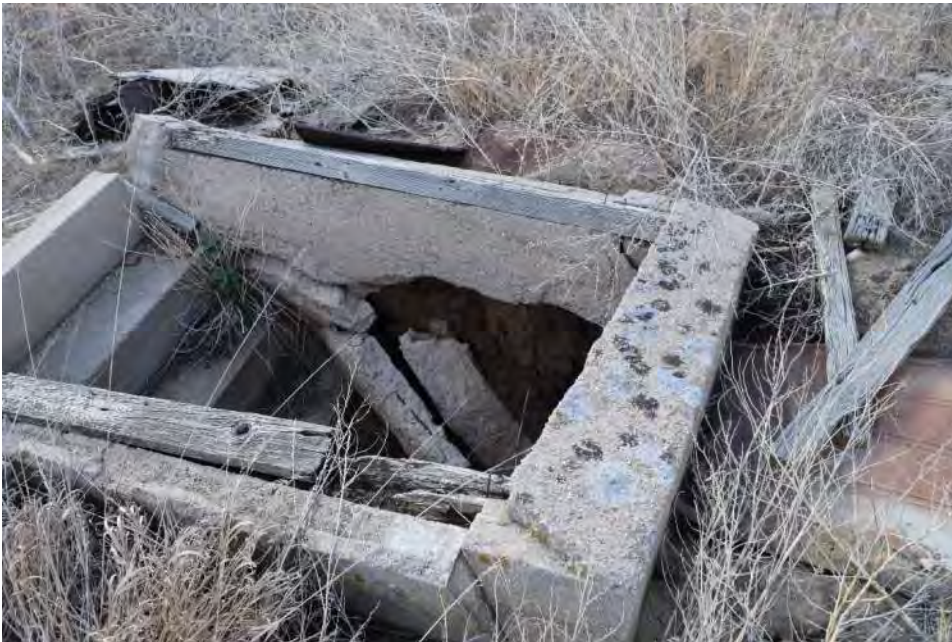
Figure 21. Broken concrete walls of the main entry of the Cellar.

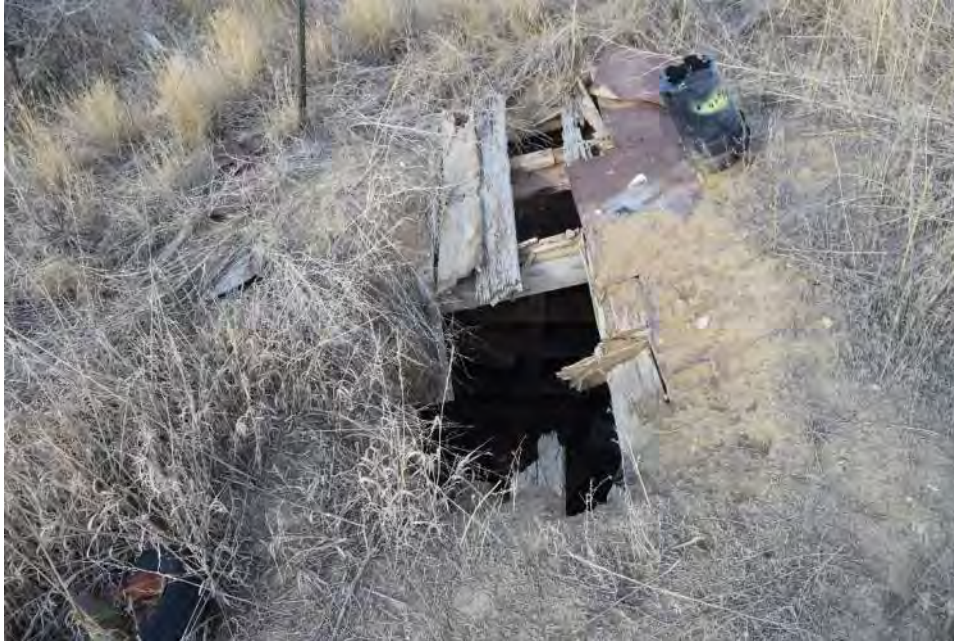
Figure 22. A cave in of the Cellar on the west side.

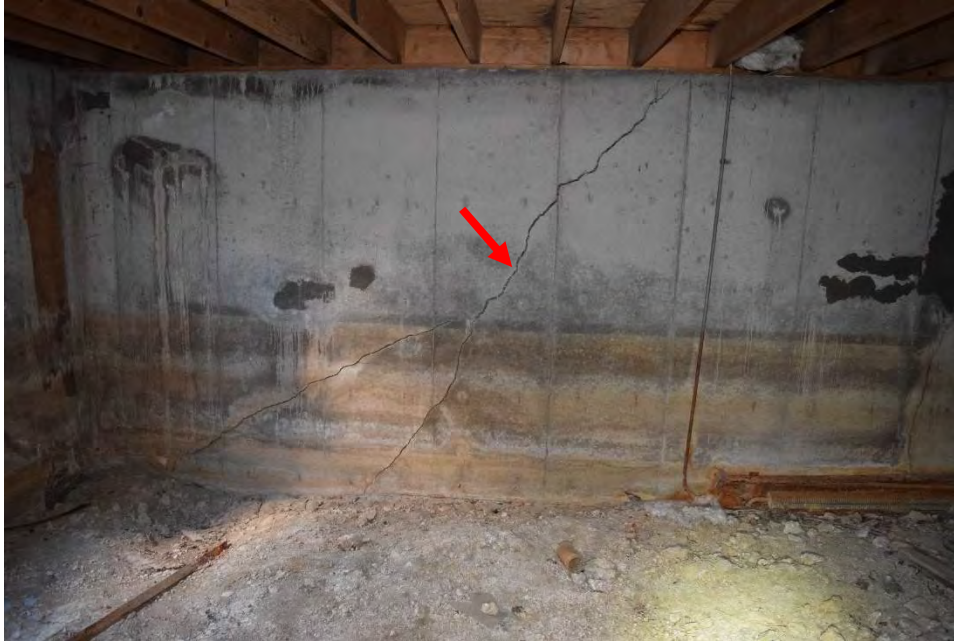
Figure 6. Large crack in the wall of the underground basement at the Original Farmhouse.

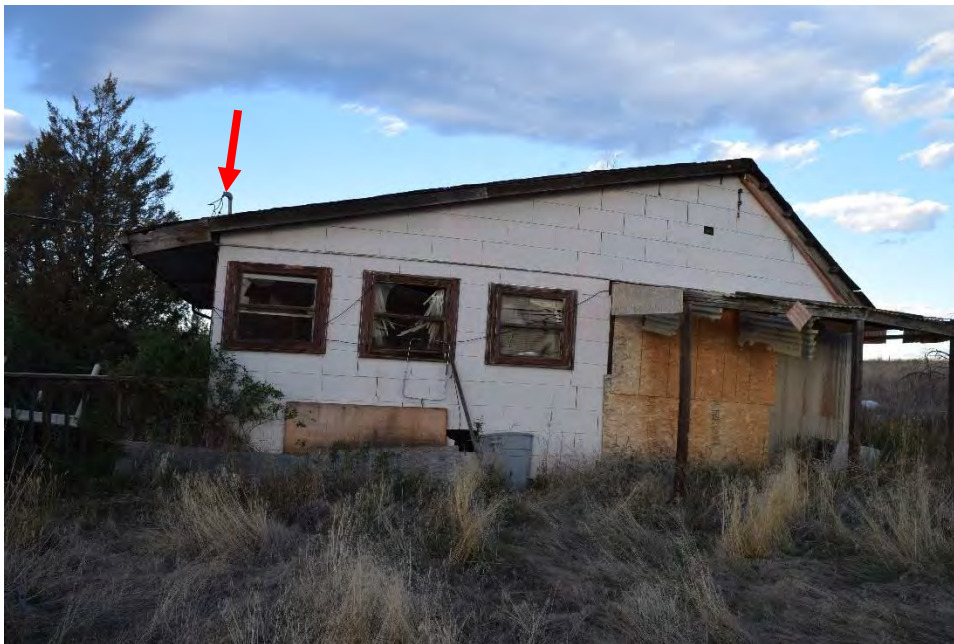
Figure 7. Wires entering the Original Farmhouse on the south side near the main entry.
