**Zone Chart**

**Irrigation Plan**

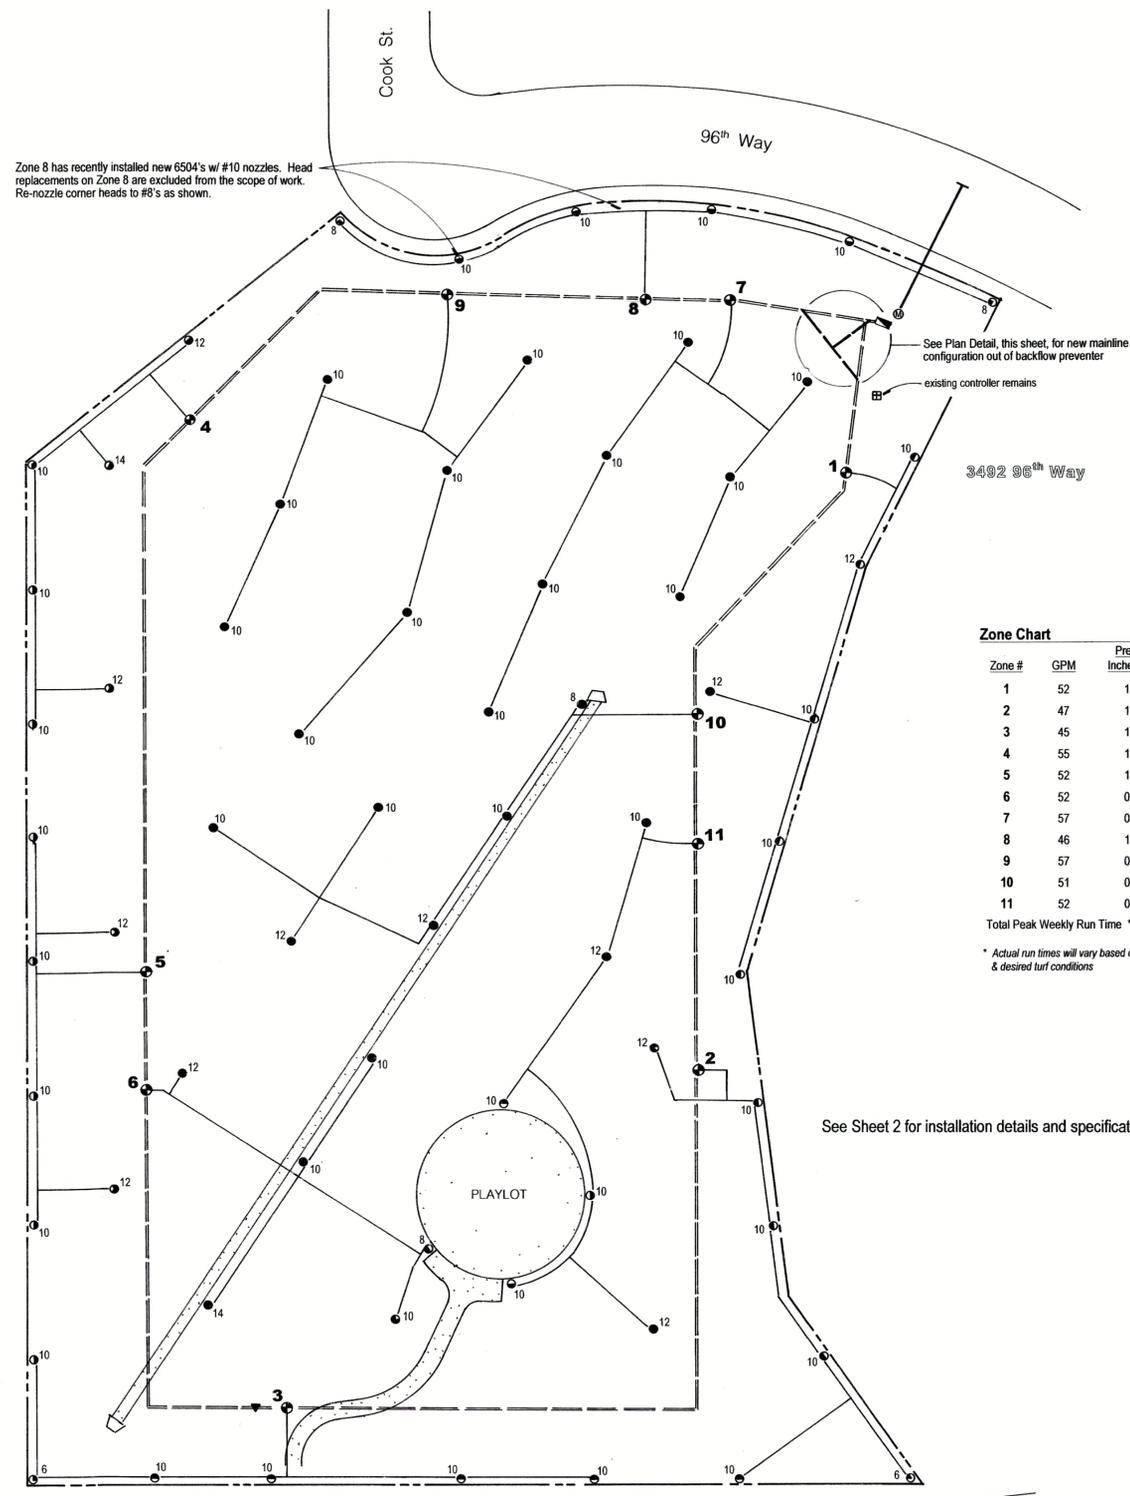
- Existing 2" copper service, meter, & backflow preventer to remain
- Existing Rainmaster Eagle controller to remain
- Existing 3" PVC mainline (approx. location)

- New Quick Coupling Valve: Buckner #QB44RCAR10 in Carson #910 10" round box w/ #910-4 green T-lid (or equal).
- New 3" CL200 solvent weld PVC mainline w/ Sch. 40 welded joints, Sch. 80 threaded joints.

- New Master Valve: Toro P-220 2" globe valve with Spears #8098-020SR steel reinforced unions upstream & downstream, in Carson #1324-12 super jumbo box w/ #1324-4L green T-lid with extension, or equal.

- New Flow Sensor: Creative Sensor Technology model #FSI-T20-001 2" PVC Tee Type (or equal). Install with minimum 24" jointless straight run of 2" PVC upstream and minimum 12" jointless straight run of 2" PVC downstream. Install in Carson #1419 standard box with #1419-4 green T-lid and extension as needed. Provide new run of #18 AWG copper 2-strand shielded cable to existing controller.

- Approx. existing control valve location. Replace existing valves with new Toro P-220 2" globe valve with upstream Spears #2621-020G 2" PVC ball valve and Spears #8098-020SR steel reinforced unions upstream & downstream, in Carson #1324-12 super jumbo box w/ #1324-4L green T-lid with extension, or equal.

- Approx. existing rotor head location. Replace existing heads with new Rainbird Falcon 6504 series head w/ stainless steel riser, or equal, part circle or full circle as shown. Install on existing swing joint. Provide new 1" PVC swing joint as detailed in not existing or if existing is damaged.

*\* used a 2" Bernad #210 cast iron gate rather than the specified Toro P220. 2 spare green wires installed in master valve box.*
