EXHIBIT C
SCOPE OF WORK
WOODGLEN INLINE HOCKEY RINK REFURBISHMENT
PROJECT NO. 23-26C

WOODGLEN PARK
11551 MADISON STREET, THORNTON, CO

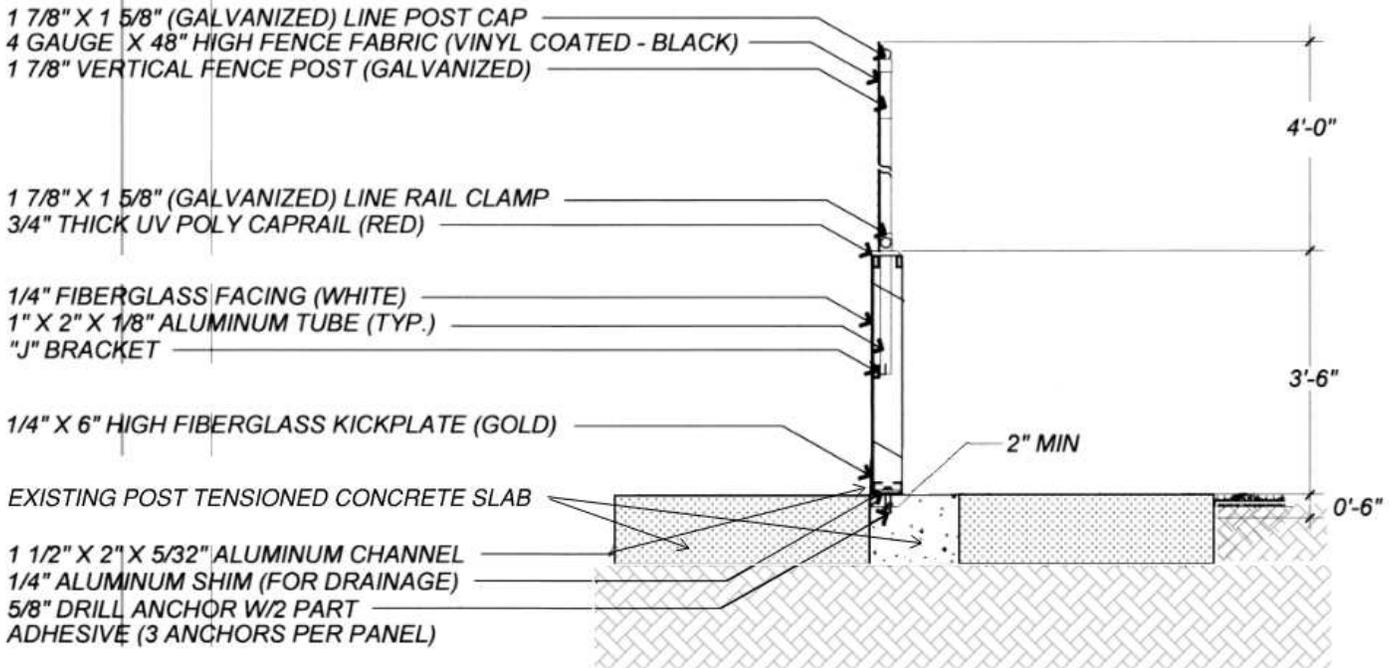
Dasherboard Detail

1. Remove and dispose of the existing fencing atop the existing dashboard
2. Remove and dispose of the existing dashboards to include support braces.
3. Replace existing dashboards to include support braces per attached details.
 - a. Please Note - Installation shall include anchors drilled in to the existing Post-Tensioned concrete slab.
4. Install 4-foot, 4-gauge vinyl coated fencing atop the dashboard per attached details.
5. Replace existing goals and nets with new.

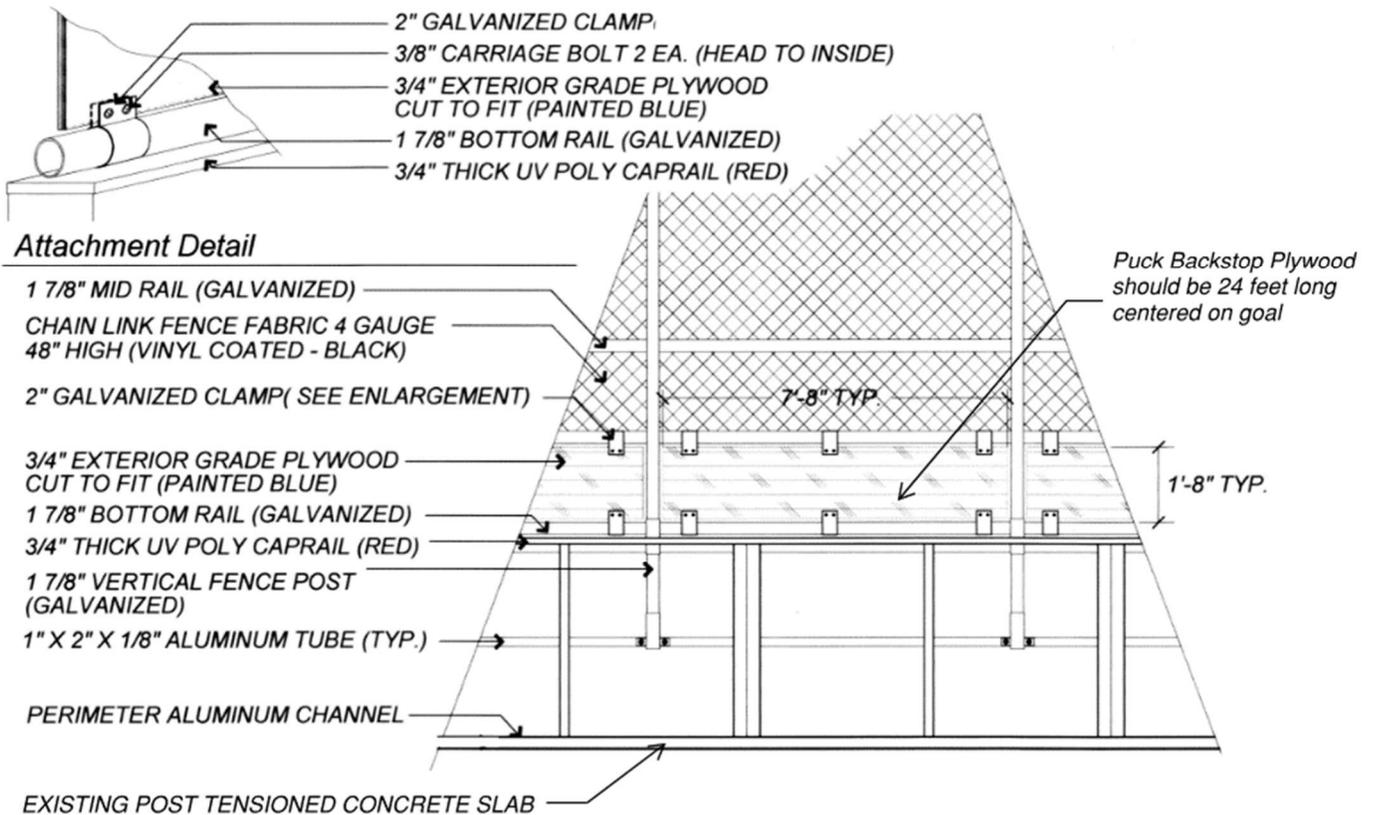
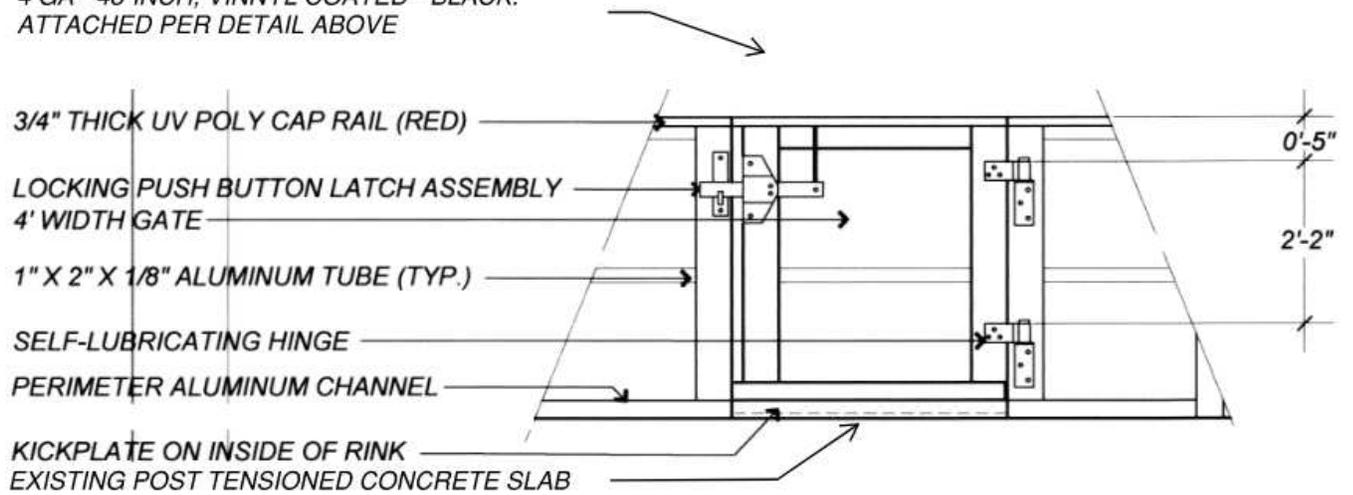
Dasherboard Door Detail

CHAINLINK FENCE FABRIC AT DOOR AS WELL
4 GA - 48-INCH, VINNYL COATED - BLACK.
ATTACHED PER DETAIL ABOVE
